Burbank Water and Power

WILDFIRE MITIGATION PLAN

2023

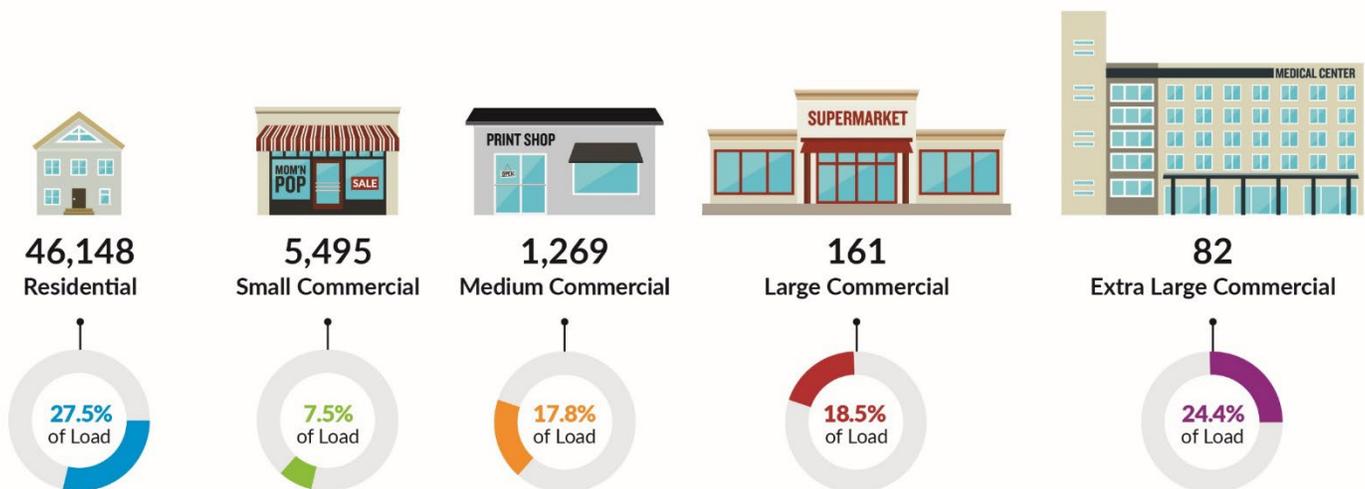
Figure 1 - BWP's electric load

Burbank has a vibrant residential community, with a housing mix of about 18,750 single-family homes that range from post-World War II bungalows to two story view homes. There are about 28,850 multifamily homes. In total, BWP currently serves 46,148 residential, 5,495 small commercial, 1,269 medium commercial, 161 large commercial, and 82 extra-large customer accounts. These customer class counts are the 3-year average through 2022.

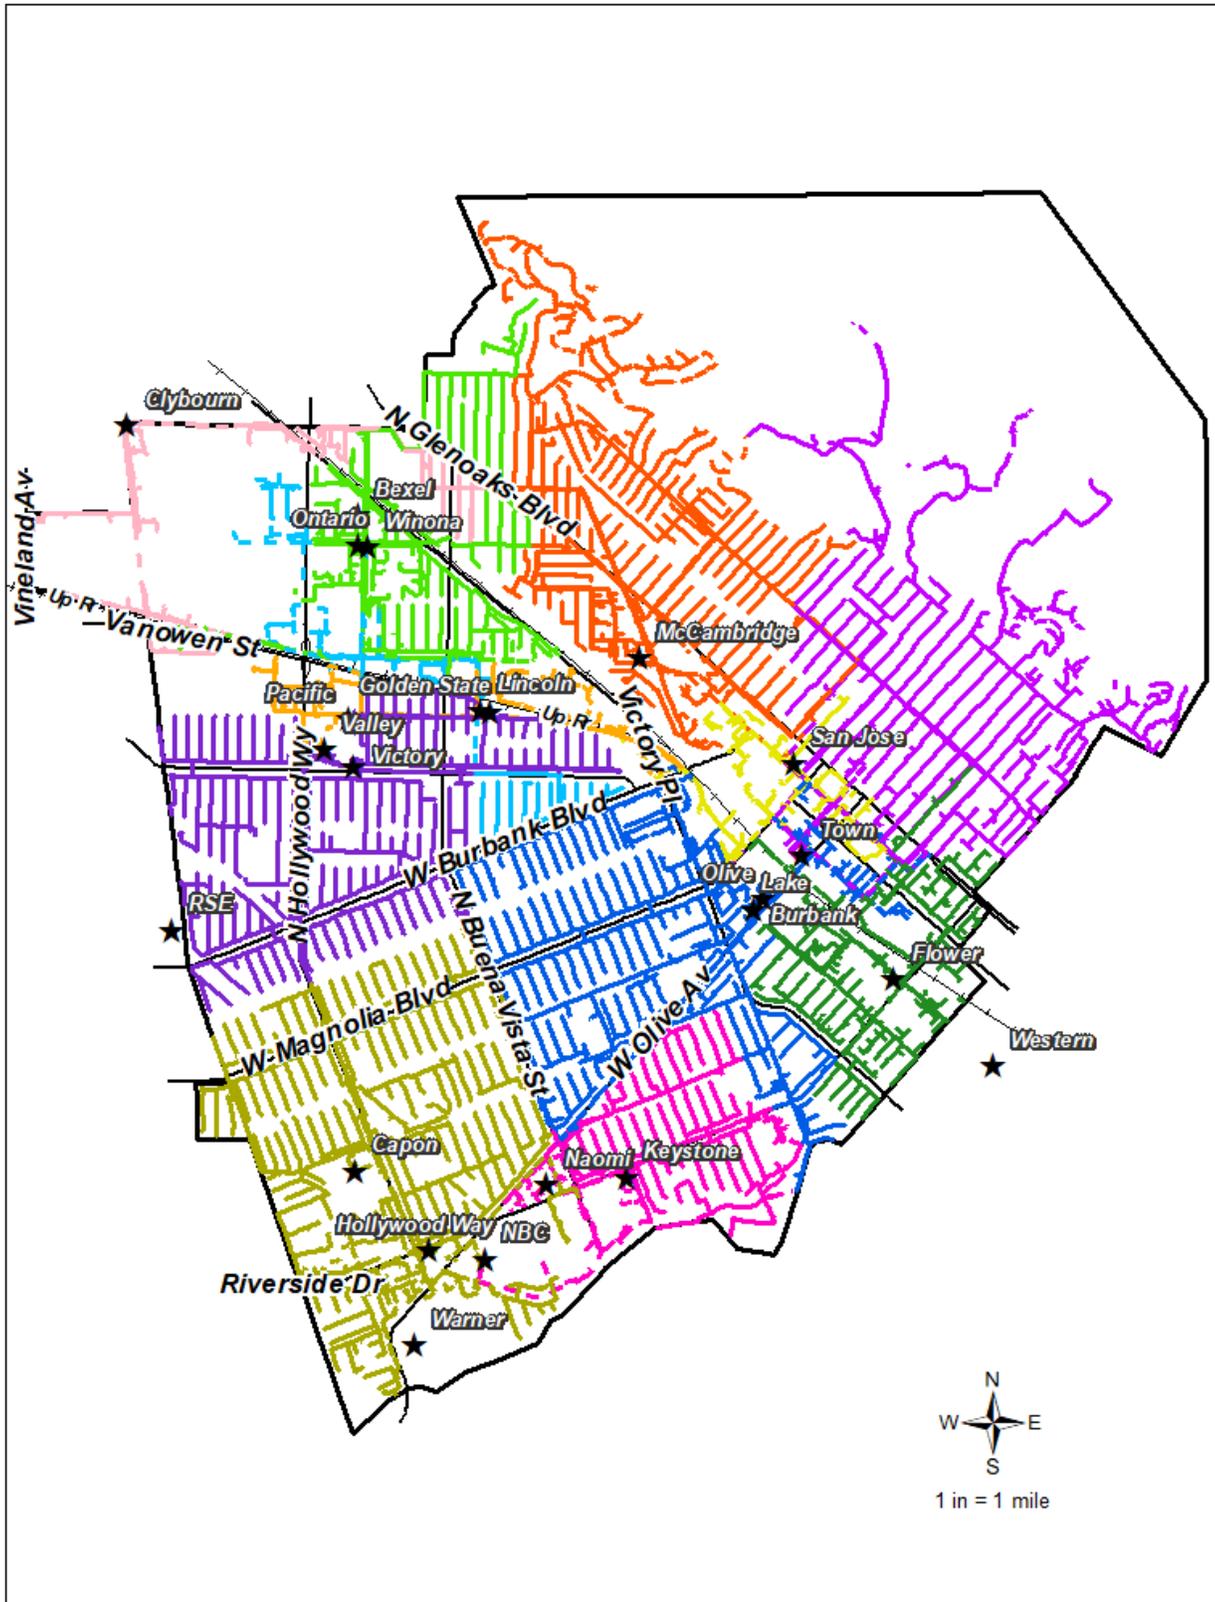
Figure 2 - BWP electric distribution system

BWP supplies electrical service to its customers through a distribution network, which includes 12 distribution substations, 2 large customer substations, 4 switching stations, 44 miles of 34.5 kilovolt (kV) sub-transmission lines, 33 miles of 69kV transmission lines, 204 miles of overhead distribution lines, 132 miles of underground distribution lines, 584 miles of overhead secondary lines, 119 miles of underground secondary lines, 10,741 poles, and 5,825 transformers. BWP’s all-time peak demand was 322 MW in 2017 but is forecast to remain flat for the next several years.

- Section 2.2 - Updated customer makeup
- Section 2.3 - Updated Electric system quantities, updated Figure 2

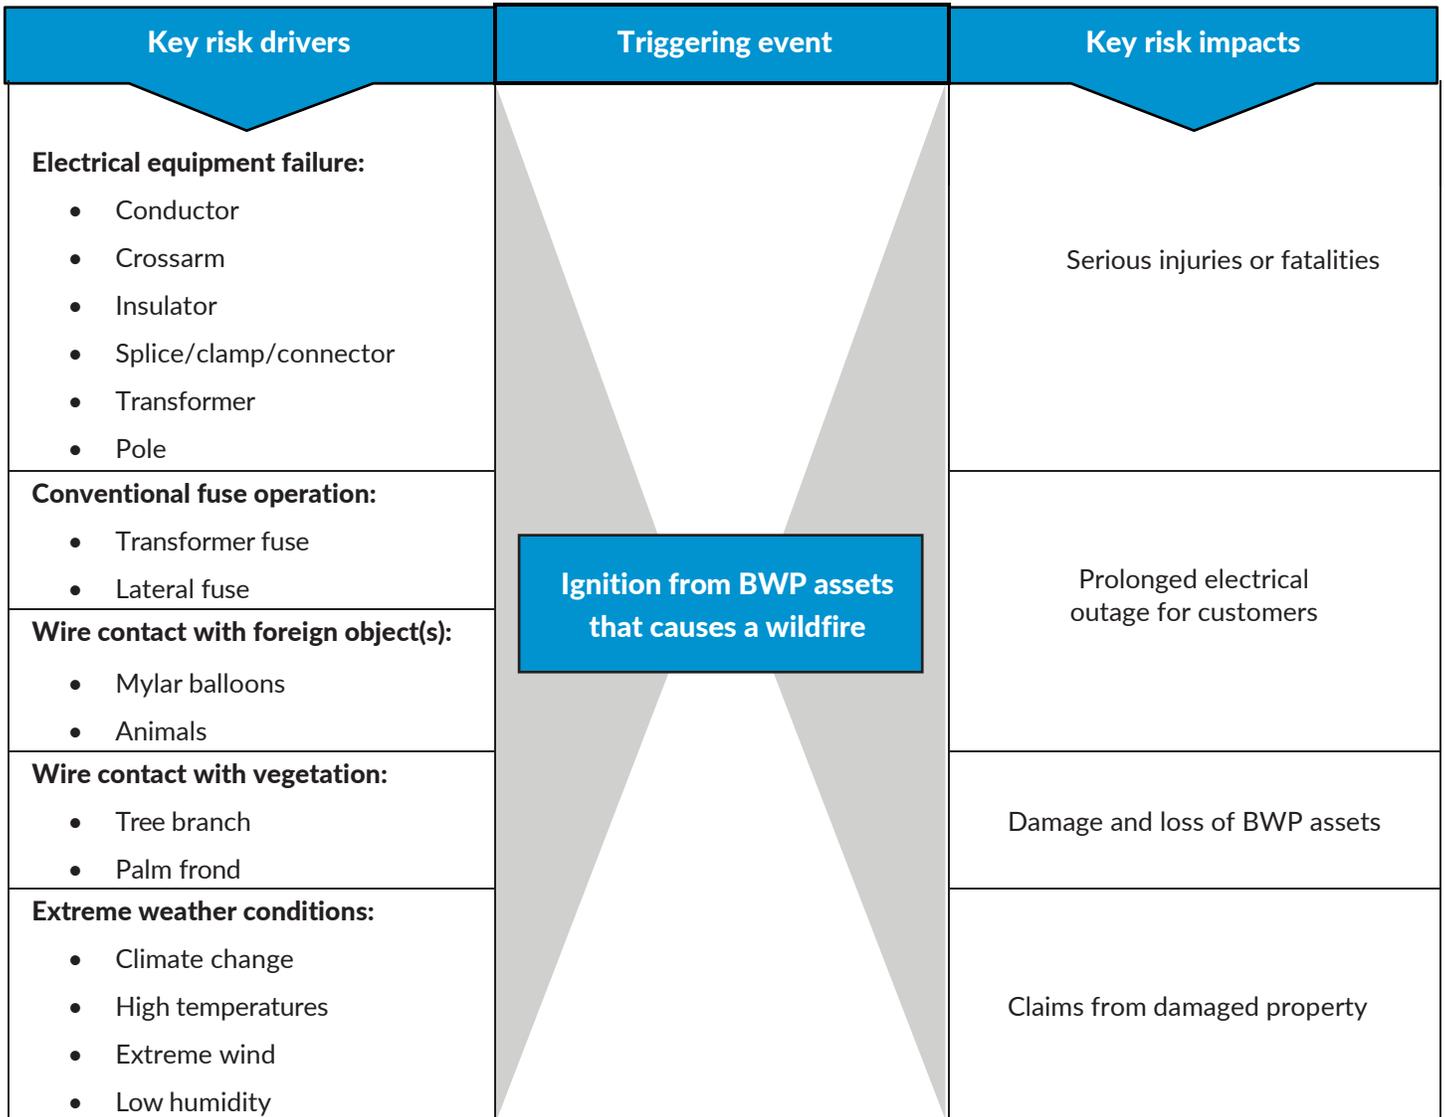
Figure 3 - BWP's wildfire risk bowtie

The risk of a vegetation ignition and potential for an uncontrollable wildfire caused by BWP electrical facilities is related to the type of vegetation (fuel bed) within its vicinity, the local/regional weather patterns, and the potential for a failure of BWP's equipment. For example, areas that include uninterrupted, natural (unmaintained) vegetation present a risk of ignition from ongoing operational activities or equipment failures. When the area also includes weather conditions that result in periodic high wind and low humidity, the wildfire risk is significantly enhanced. Both of these weather conditions can occur in BWP's Tier 2 HFTD area. A bow tie analysis was conducted to identify these risk drivers as well as their potential resulting impacts. Figure 3 provides the risk bow tie diagram, which summarizes the assessment process.

Risk drivers are important to identify because they are the primary ways in which BWP electrical facilities could result in a catastrophic wildfire. The center of the bow tie chart is the triggering event, which is an ignition caused by a BWP asset resulting in a catastrophic wildfire. During the wildfire threat assessment, five categories were identified as potential drivers for causing fire ignitions:

If one of the risk drivers listed above were to occur, resulting in a wildfire ignition caused by BWP electrical facilities, there could be potential consequences for BWP as presented on Figure 3.

- Section 4.2 - Figure 3 revised key risk impacts order
- Section 4.2.2 - revised to match Figure 3
- Section 4.3.1 - Updated Figure 4
- Section 4.3.1 - Added HFTD expected revisions and BWP preliminary review and expectations
- Section 4.4 - Updated Table 3, Table 4, and Figure 6 to reflect current system configuration. Updated Table 5 total risk drivers events based on new data from 2022.
- Section 4.5 - Added new risk modeling developed to prioritize and track mitigation
- Section 4.6 - Updated Table 6 mitigation activities to align with Table 2
- Section 4.7 - Added comments regarding comprehensive update

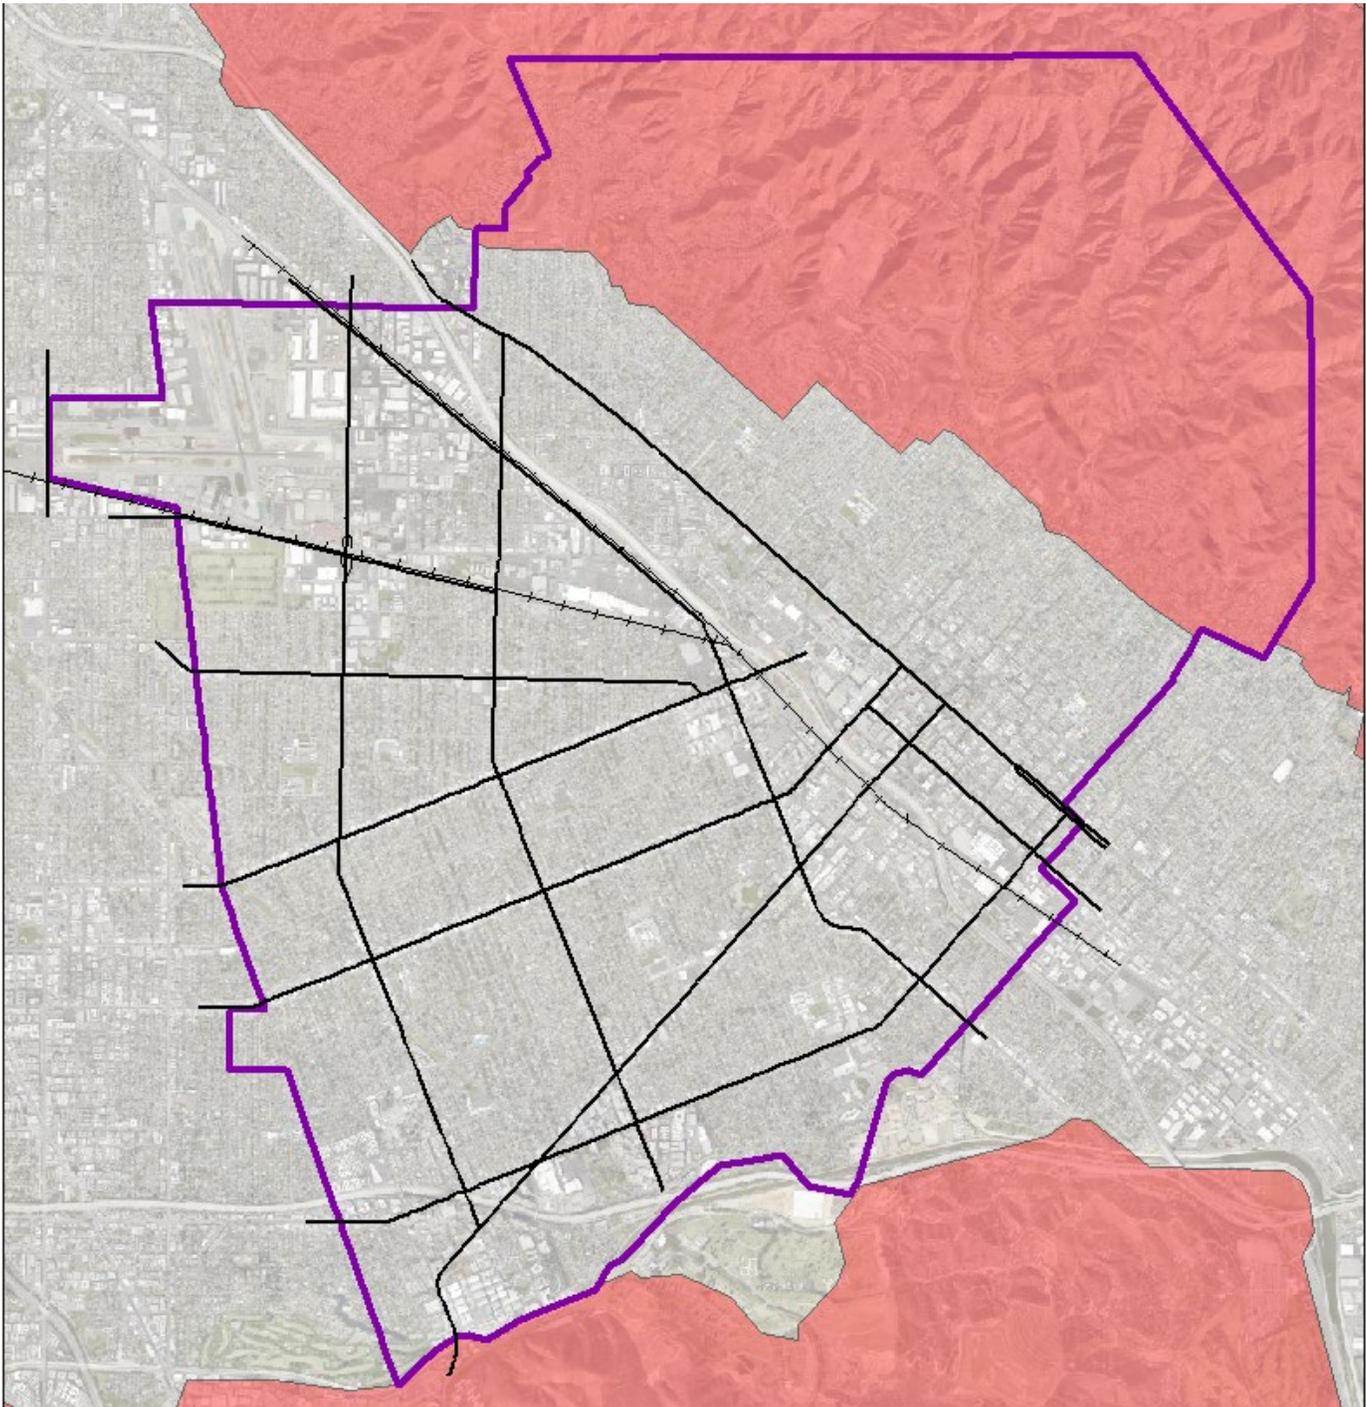
Figure 4 - BWP's Tier 2 high fire threat district

Map which designates high-fire threat districts (HFTDs) throughout the State of California. The CPUC Fire-Threat boundary map ranks HFTDs based on the need to increase infrastructure resiliency to mitigate the wildfire threat posed by electric infrastructure. The CPUC Fire-Threat Map is comprised of Tier 2 HFTDs (elevated risk of potential impacts to people and property) and Tier 3 HFTDs (extreme risk of potential impacts to people and property).

In the map development process, BWP served as a territory lead, and worked with local fire & government officials to identify the areas of BWP's service territory that are Tier 2 or Tier 3 HFTDs. It was determined through the development process and affirmed by both a peer review and a team of independent nationwide experts led by the California Department of Forestry and Fire Protection (CAL FIRE), that a portion of BWP's service territory is situated within a Tier 2 HFTD. Additionally, no portion of BWP's service territory falls within a Tier 3 HFTD.

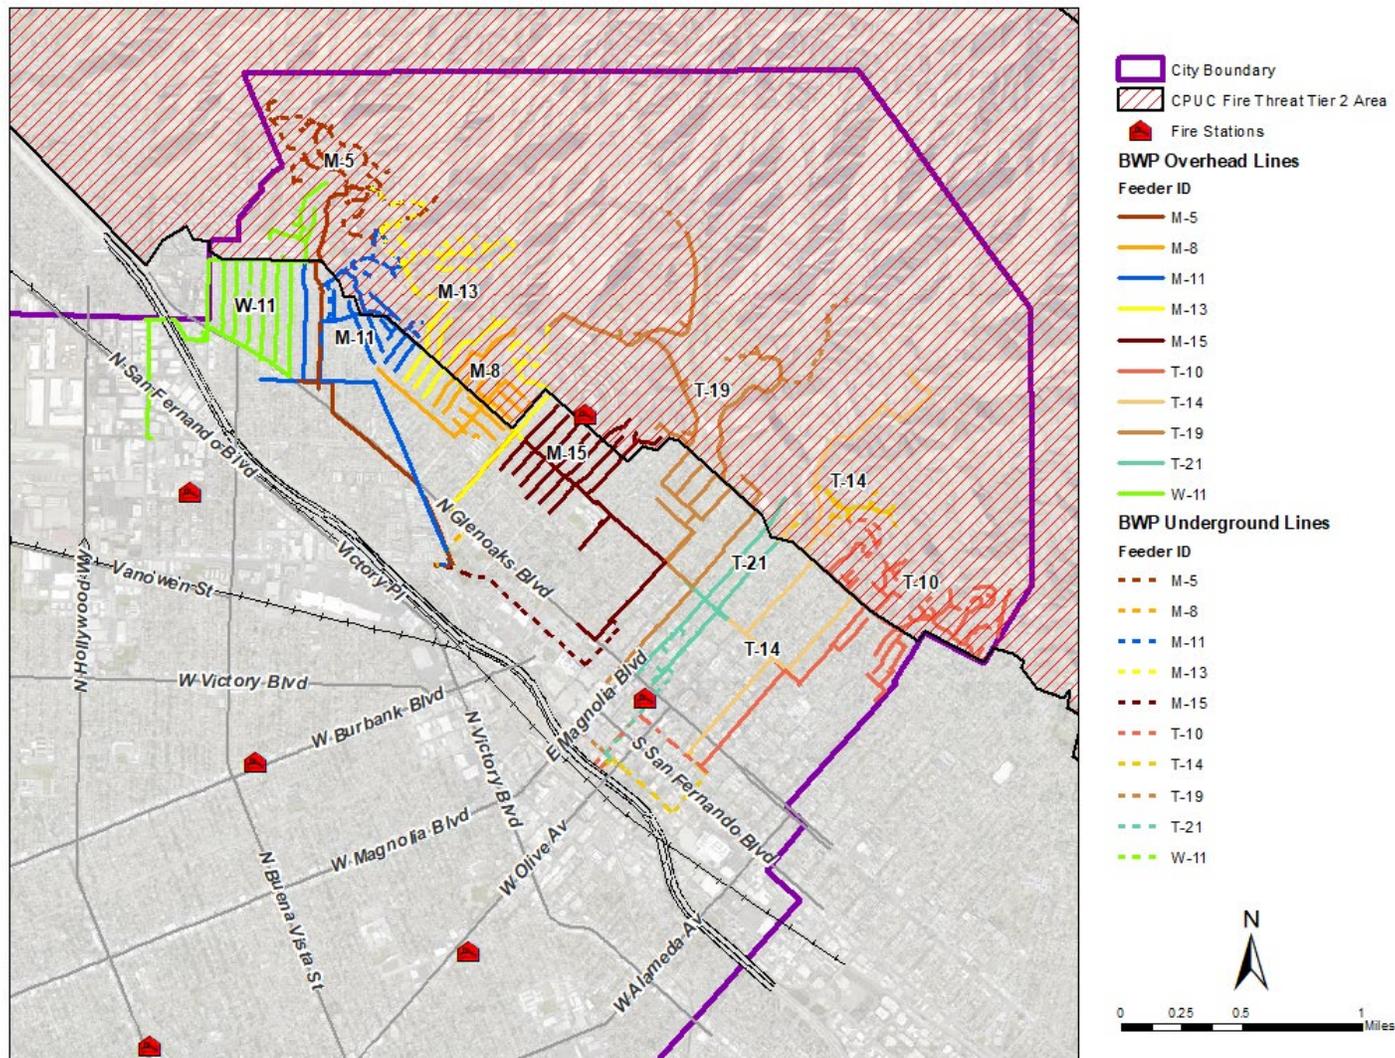
Figure 6 - Electrical facilities within the Tier 2 HFTD

Figure 6 presents the portion of BWP's service territory (e.g., feeder lines and equipment) within CPUC fire-threat areas. As illustrated in Figure 6, BWP's electrical system is located within both Tier 2 HFTDs, and areas not considered within the HFTD (referred to as outside HFTD in this WMP). Table 3 includes the breakdown of BWP's electric system that falls within the Tier 2 HFTD.

Table 4 provides a detailed inventory of BWP assets within Tier 2 HFTD area organized by distribution feeder circuit. As indicated, there is a total of approximately 25 miles of distribution lines in Tier 2 HFTD, with 14 miles underground lines and 11 miles overhead wire. The overhead wire and related components are the focus of this WMP as they represent the primary source of potential wildfire ignitions. Approximately 56 percent of BWP-owned electrical lines in the Tier 2 HFTD area are currently underground, which significantly reduces the threat of fire ignition.

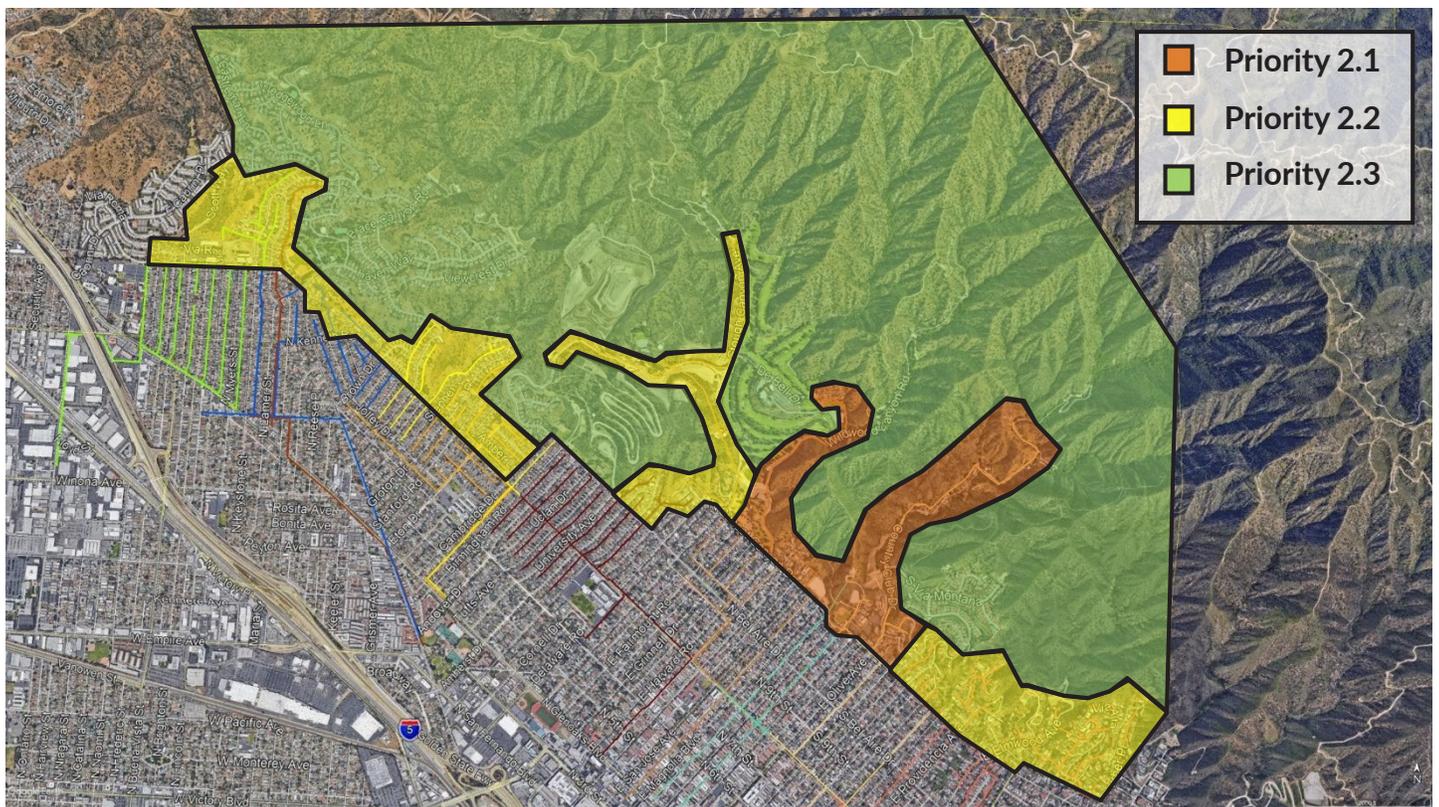
Figure 7 - Wildfire risk prioritization within the Tier 2 HFTD

Priority level 2.3 – Tier 2 HFTD with no overhead electrical facilities

By the end of 2020, BWP completed pole loading analysis of all poles inside BWP's Priority 2.1 Zone (see Figure 7) having dense vegetation near overhead facilities. BWP will continue to perform pole loading analysis on all poles requiring replacement, during the design phase of each replacement.

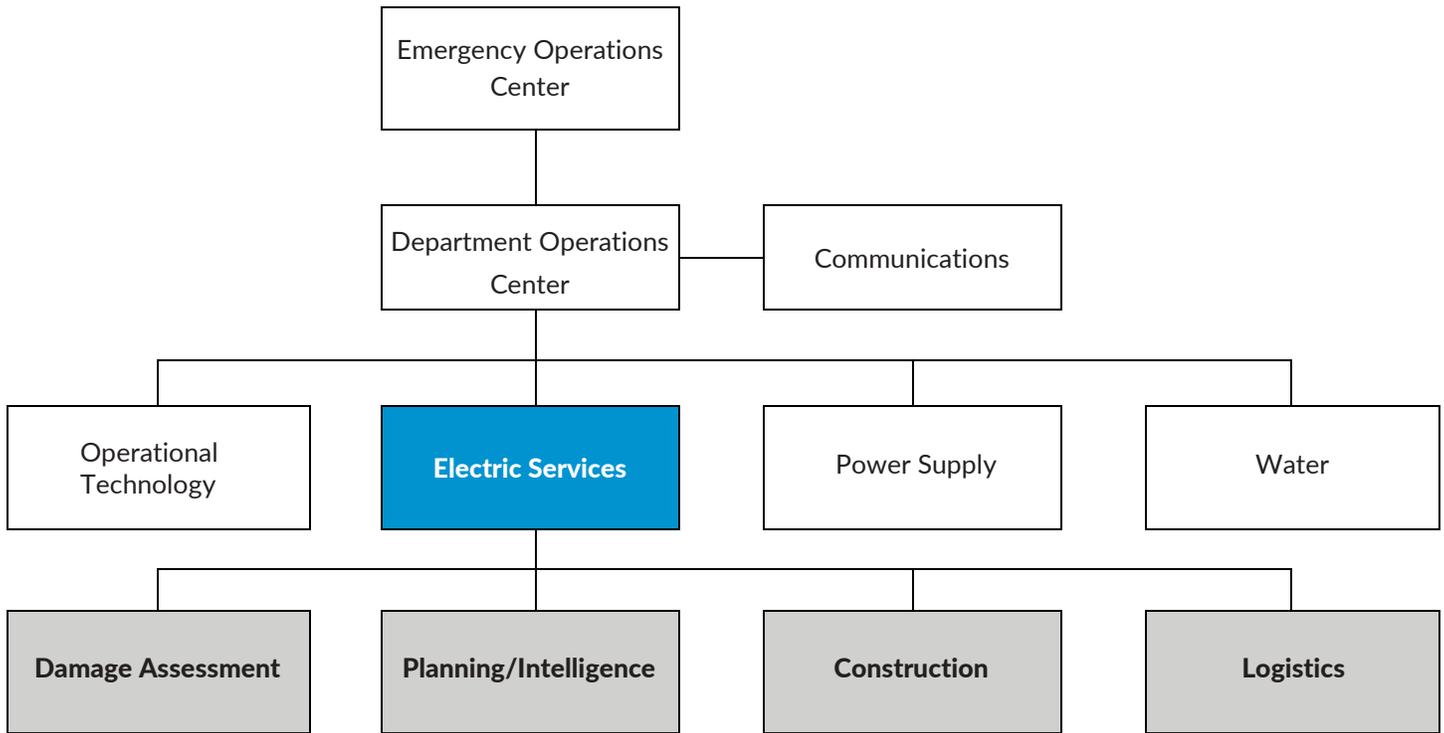
Figure 8 - BWP Emergency Response Team organization

The Electric Services Response Team is comprised of four response teams: damage assessment, planning/intelligence, construction, and logistics as presented in Figure 8. The responsibilities of each response team are described in Table 10 below.
